## **Cape Town's Stormwater Ponds: investigating the amenity that they provide**

*Department:* Civil Engineering

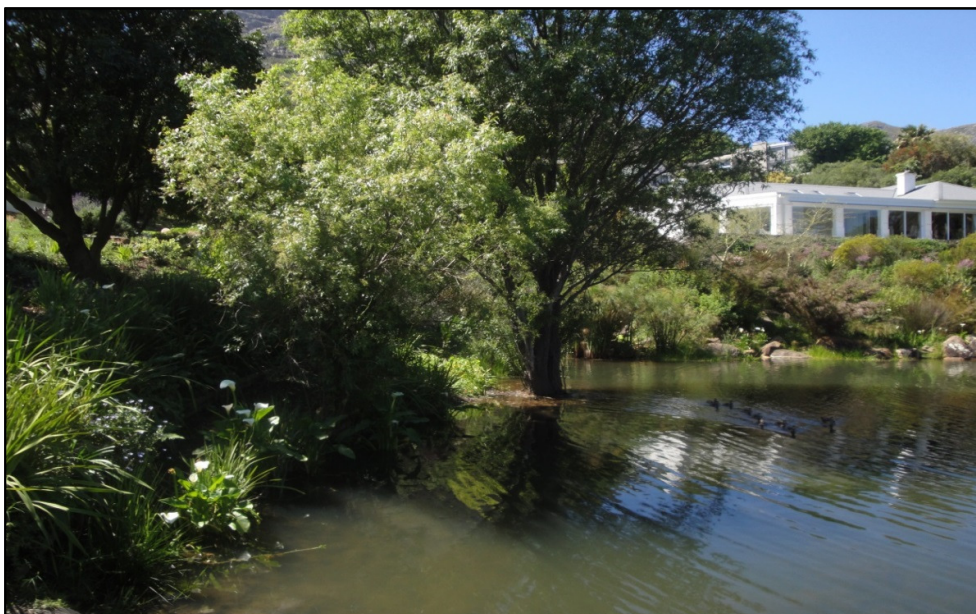
Figure 1: An example of a retention pond that provides diverse plant and wildlife ecosystems

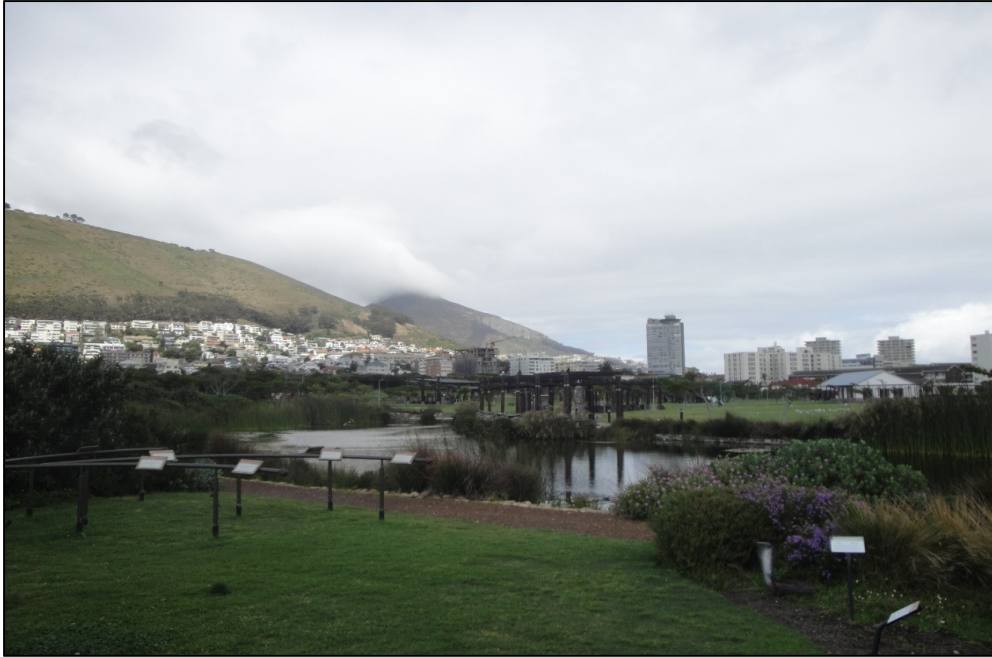
**Figure 2: A retention pond that provides an educational multi-functionality**

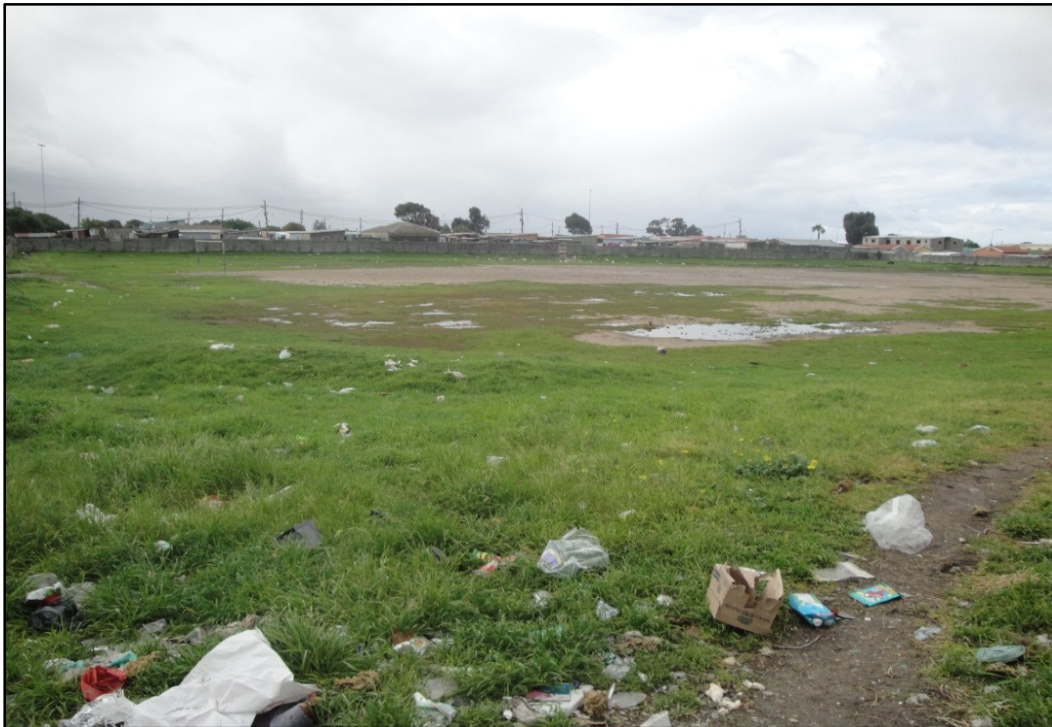
**Figure 3: A detention pond in a low affluent area in which dual use has led to the erosion surface material**

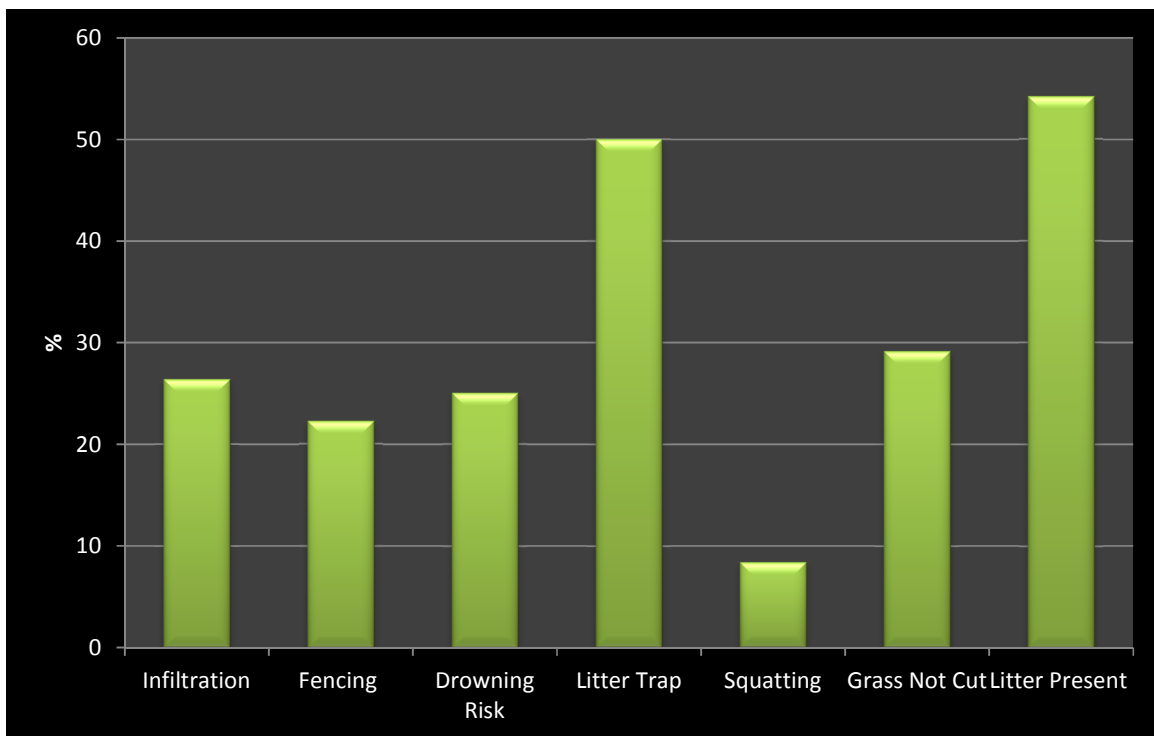
**Figure 4: Percentages of negative amenity contributions that were present in investigated ponds**

The general percentage of negative amenities attributed to the investigated ponds was low. Certain retention ponds posed drowning risks however, this is a typical disadvantage associated with retention ponds. On visual inspection, only 8% of the ponds showed evidence of squatting. However, it was revealed during discussions with City of Cape Town officials that squatting in stormwater ponds is a

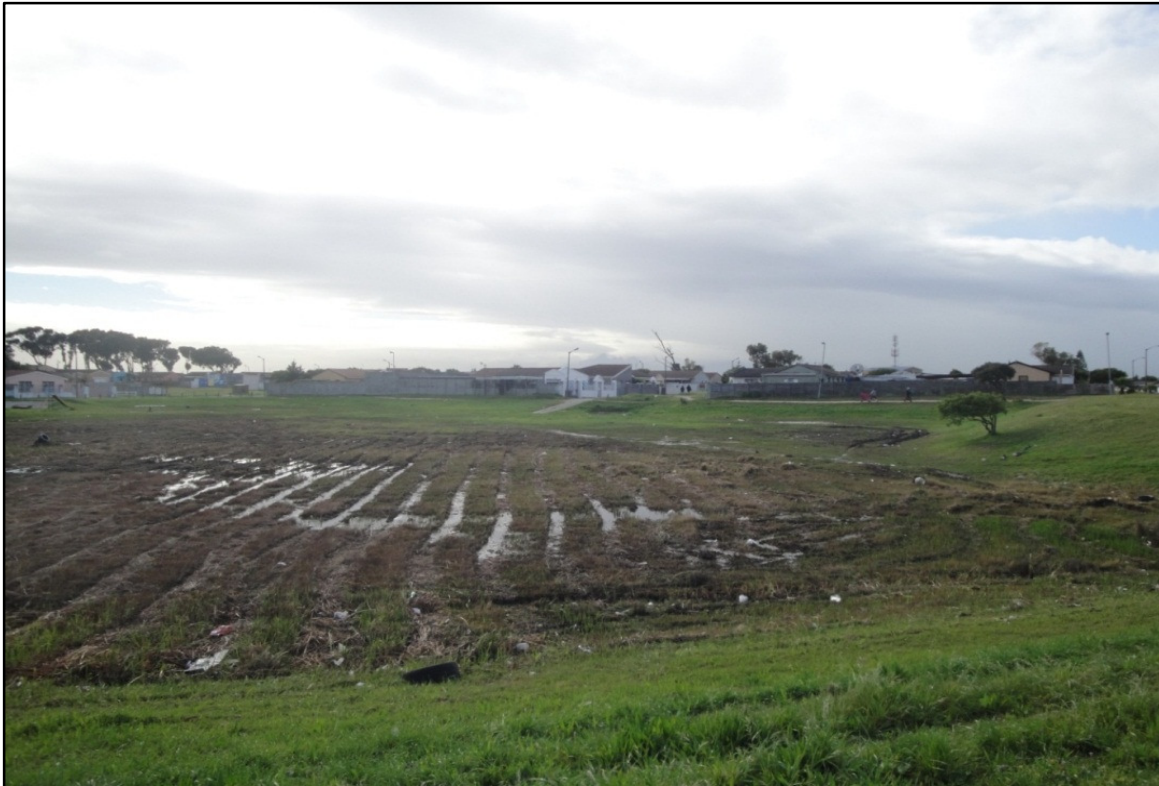
During the pond investigations, the survey recorded certain negative attributes. Those that were documented are listed on the horizontal axis of Figure 4. In the instances where infiltration had caused visible marshy areas on the basin of the pond, it was considered a negative attribute (Figure 5). Fencing of the pond was also considered a negative amenity, as it potentially restricted access. The negative amenity 'litter trap' was defined as a pond would naturally accumulate litter, which was from the accumulation of litter in the outlet of the pond. However, 'litter present' was simply defined by obvious litter visible around the area of the pond.

**Figure 5: Degradation of amenity due to infiltration**

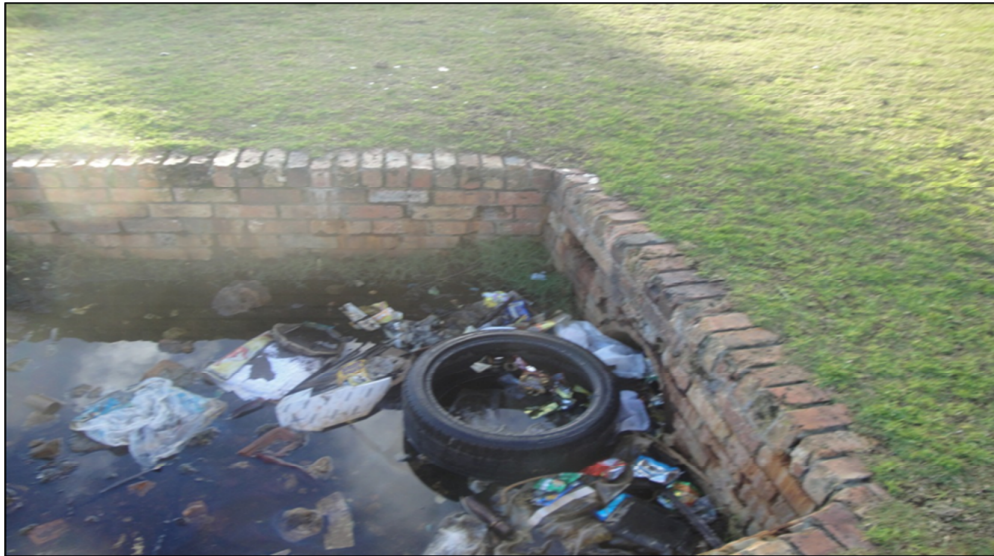
The most notable negative attribute associated to the investigated ponds was 'litter present'. 53% of the total ponds that were investigated had clearly visible litter. Further, 50% of the total investigated ponds were 'litter traps' and visible litter ponds' outlet. Upon interviews with local residents during pond investigations and with subsequent interviews with City of Cape Town officials, litter was the most often reported problem with the City's stormwater ponds. The abundance of litter within the ponds originates from on-site dumping and littering as well as litter entering the stormwater network and then being deposited into the pond. The litter has severe negative impacts on the ponds, reducing the ponds' storage capacity by blocking

outlets as well hugely reducing its aesthetic appeal. An example of this can be seen in Figure 6.

**Figure 6: A stormwater pond classified as 'litter trap' due to litter accumulating in the outlet**

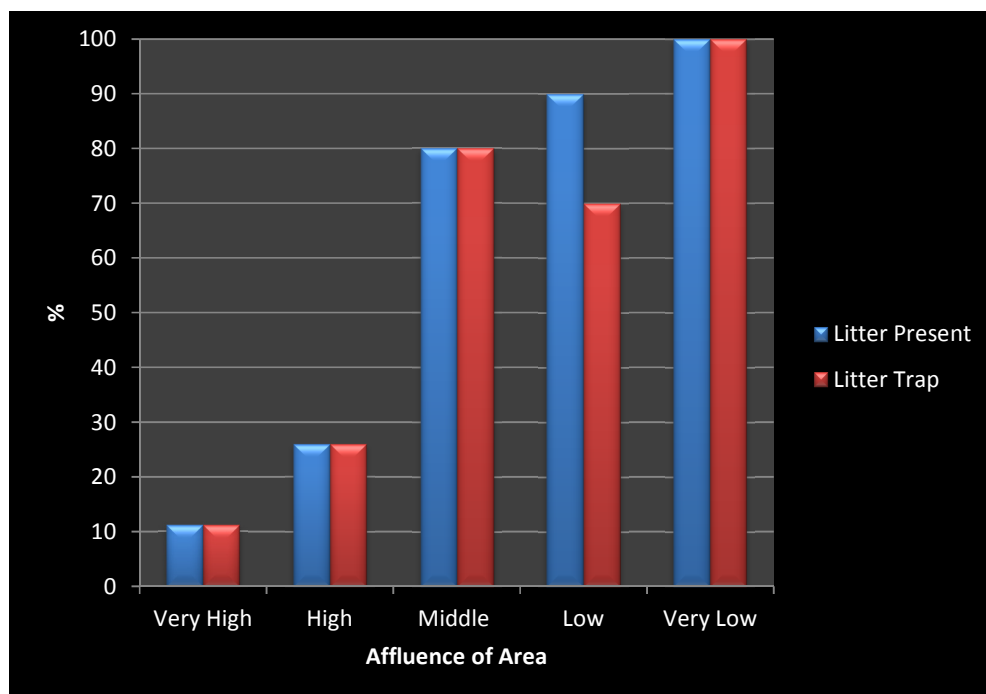
In further analysis of the investigated ponds, it was evident that the percentage of ponds in which litter is present increases with decreasing affluence (Figure 7). A possible reason for this result could be due to the number of backyard shacks or informal dwellings in less affluent areas. Catering for refuse collection for these types of dwellings is a huge challenge (City of Cape Town, 2014). From Figure 4 and 7, it is

**Figure 7: Percentage of pond per affluence area in which litter is present or is associated as a litter trap**
