Groins or Not: Some environmental challenges to urban development on a Lagos coastal barrier island of Lekki Peninsula

J. N. Obiefuna¹, A. Omojola², O. Adeaga³, and N. Uduma-Olugu⁴

Department of Architecture, University of Lagos, Nigeria ^{1,2,3,4}

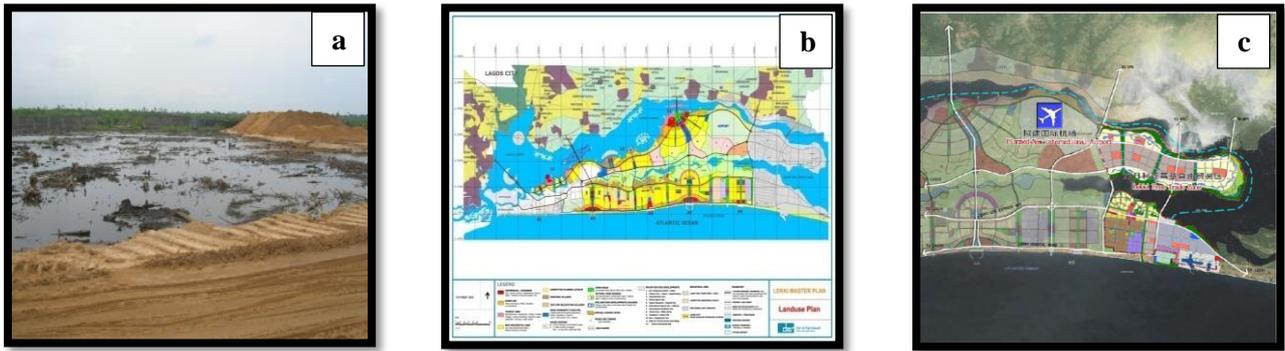
Figure 1.1a-c: a) Current development and wetland reclamation in Lekki Peninsula; b) Lekki Master Plan proposal (source: Dar al-Handasah, 2009 and c) Lekki Free Trade Zone (Source: China- Nigeria ETCZ, 2009).

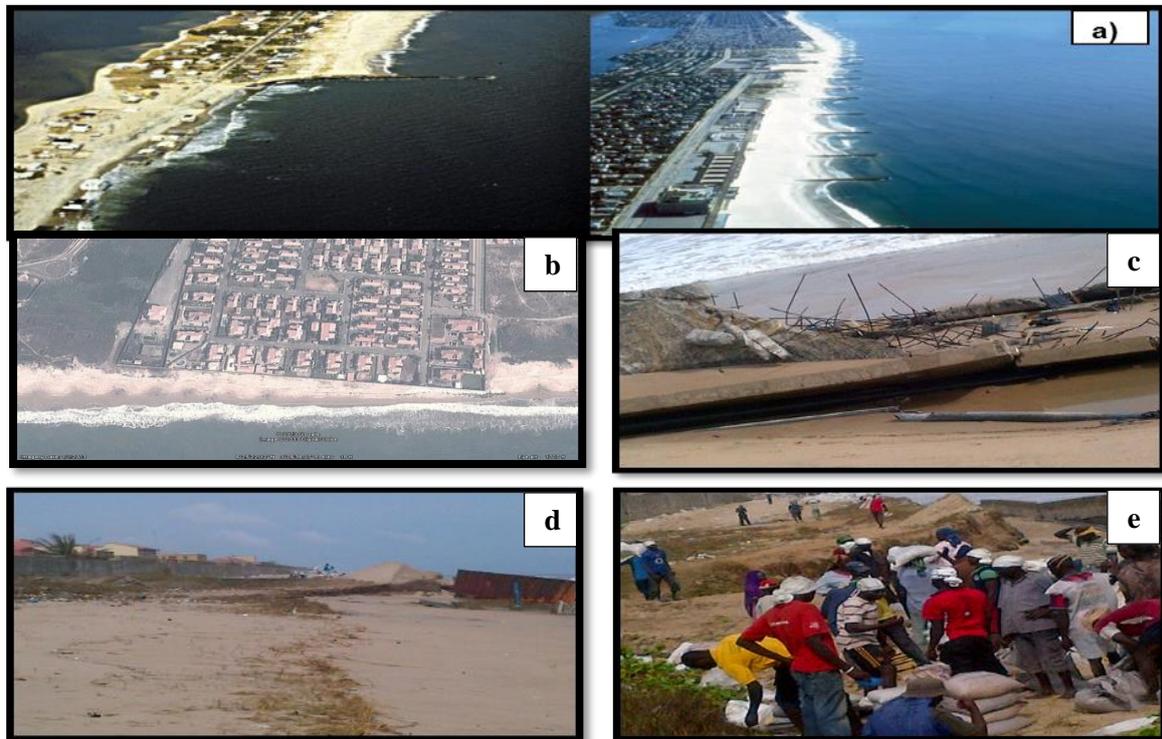
Plate 1.1a – e: Beach erosion and devastation on barrier island coastlines. a) Beach Erosion and deposition are regular features of barrier island coastlines. Groins interrupt the natural sand flow and can exacerbate erosion on downdrift side of the coastline. (Source: Tanski, 2007). b) 2013 imagery showing erosion around Goshen Beach Estate, Lekki (source: Google Earth, 2013). c) Goshen Beach Estate - remains of shallow-depth retaining wall after the ocean surge of 24-8-12, d & e- Goshen Beach Estate - devastation from the surge of 24-8-12 & workers readying sandbags as barriers to ocean surge.

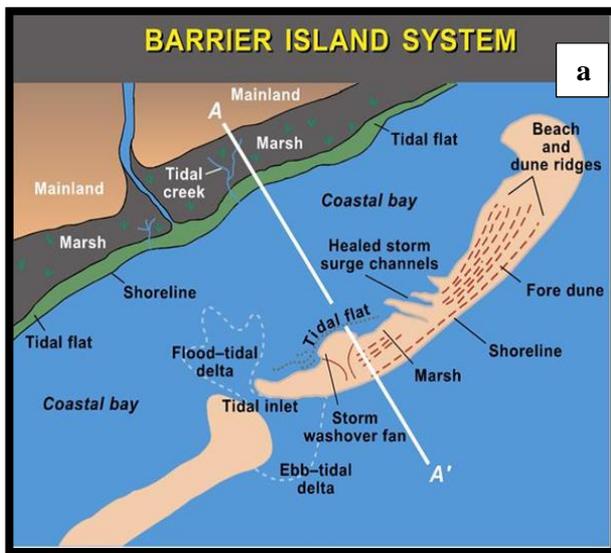
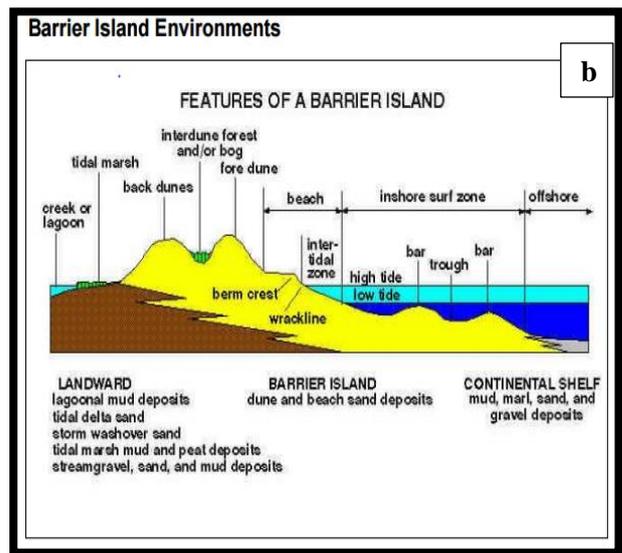
Figure 1.2 a-b: a) Typical barrier island system; b) Typical barrier island cross section – ocean to the lagoon or bay. (Source: <https://sharkresearch.rsmas.miami.edu/assets/pdfs/learning-tools/>).

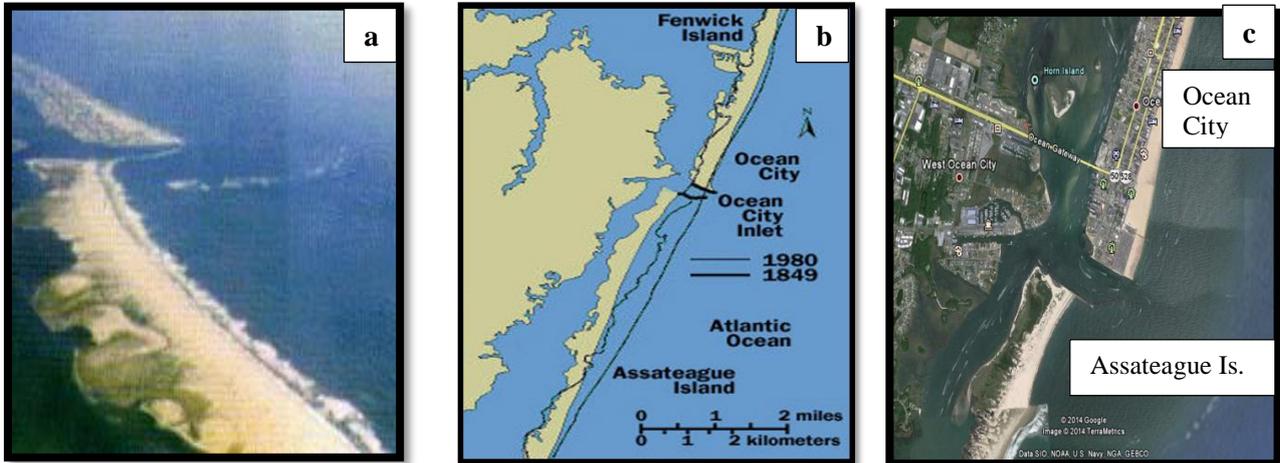
Figure 1.3 a-c: Changes in Assateague Island, Maryland (USA) as a result of accelerated erosion from the man-made rock jetties of Ocean City Inlet. a) Photo of the inlet; b) Map of the area with outline showing the position of the island in 1849 and in 1980; c) Imagery of the same island in 2010 (Sources: Freudenrich, 2014, <http://science.howstuffworks.com>, 2014. Google Earth, of 7-4-2010).

emplaced perpendicular to the coast causes accretion/deposition on the upper end and erosion on the lower end while the northern tips of barrier islands here tend to be eroded with the southernmost tips elongated with sand deposition (Mcharg, 1971). In this light, the building of rock jetties stabilised Ocean City Inlet, Maryland but they altered the normal north - to - south sand transport by longshore currents and initiated accelerated erosion and deposition. This resulted in sand build up behind the north jetty while the sand below the south jetty was quickly eroded. This accelerated erosion has shifted Assateague Island south of the inlet about 0.8km inland (Fig. 1.3 a-c). The other example of

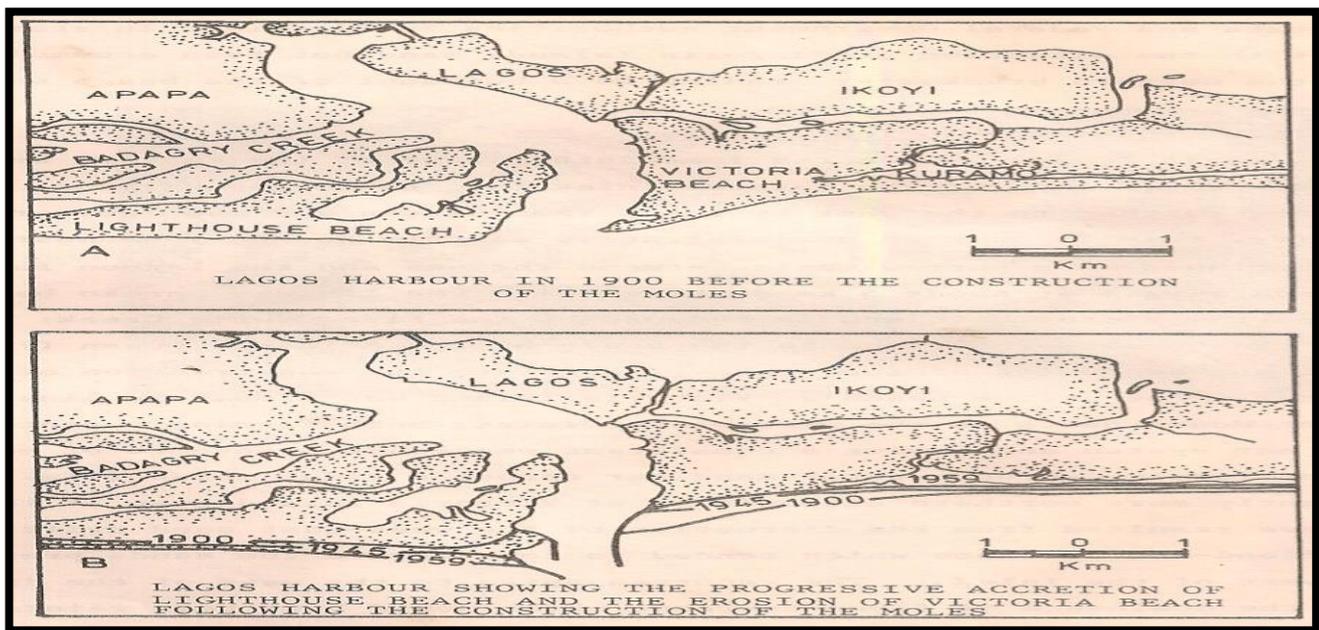
Figure 1.4: The Lagos coastline showing V.I. and entrance to Lagos harbour before (A) and after (B) the construction of the breakwaters (Source: Ibe, 1988).

development effects is from Victoria Island. The construction of the almost perpendicular breakwaters from 1908 to 1912 at the entrance of Lagos harbour initiated a phenomenal beach erosion of 25 - 30 m/yr. east of the eastern mole in Victoria Island (Ibe, 1988). This erosion as determined through aerial photographs saw the shoreline recede by about 2km threatening the heavy

development on the frontage Ahmadu Bello Way. This was while progressive accretion was occurring on Lighthouse beach, behind the west mole (Fig.1.4a, b). Although this is currently being tamed by the construction of Eko Atlantic City project, obvious indications are that this phenomenon may have shifted further eastwards to the Peninsula.

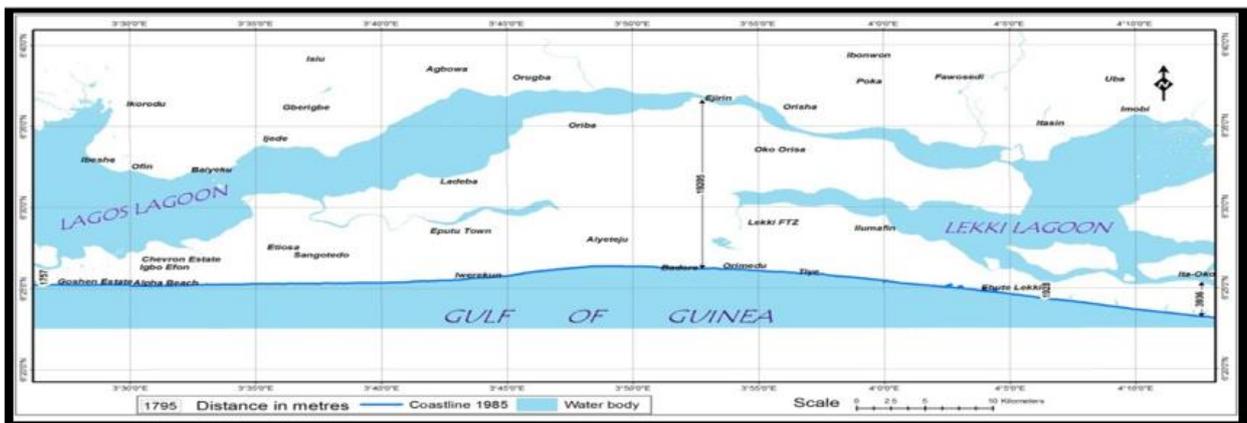
Figure 3.1: Transects of Island width in 1984/85.

show that island width was narrowest in the west (Maroko area, Meridian 3.44270E) at 1.76km, in the east at 1.93km and in the middle of the island at 19.1km (Fig. 3.1). This transect on Maroko area on Google imagery between 2001 and 2013 shows that island width has reduced to 1.52km by 2013 due to coastal erosion. Elevation distribution (Fig. 3.2 & Table 3.1) confirms the Peninsula as mainly low-lying with 37% at 0.5 - 3m and 63% at 3 - 5m above m.s.l. Eti-Osa LGA, the smallest of the area councils, is the most low-lying (Fig.3.3) with 0.5-3m (78%) dominant while its Atlantic coastlines are mostly at 0.5-1.5m. The heights of 3-4m dominate in Epe (62.8%) and Ibeju Lekki (59%). Extreme flood hazard potential on planar water levels (0.51-2m; Fig.3.4) was mainly in Eti-Osa LGA. Results of drainage analysis show the existence of minimal drainage basins over the Peninsula (Fig. 3.5). Results on beach erosion (Table 3.2) also show that the maximum rate of erosion occurs mainly in Eti-Osa LGA at about 22.75m yr⁻¹ around Kuramo Waters decreasing to 5.5m yr⁻¹ around Goshen Estate and minimal in the east (Fig. 3.6). Kuramo Waters, a formerly enclosed water body was observed to have been breached by the Atlantic Ocean in 2012. Similarly, Goshen Estate’s fence was measured at 14.80m on Google Earth imagery of 17/4/2012 but had reduced to 11.21m from wet/dry or high water line in 2013 after the ocean surge of July 2012 (Plates 3.1a, b). If any doubt existed on the veracity of the erosion results, a subsequent Google Earth imagery of 5/3/2014 (Plate 3.2) clearly showed new groins constructed in this vicinity as apparent confirmation of extant serious erosion.

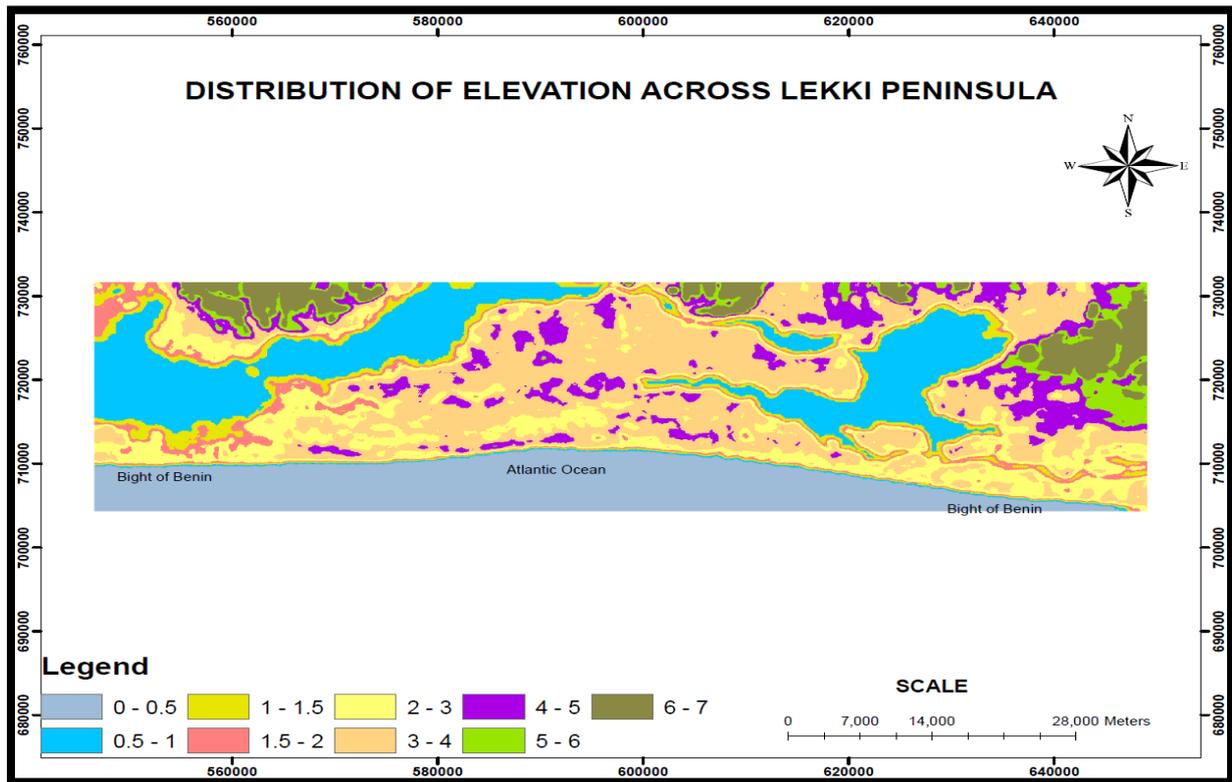
Figure 3.2: The distribution of elevation on Lekki Peninsula (Source: SRTM DEM data).

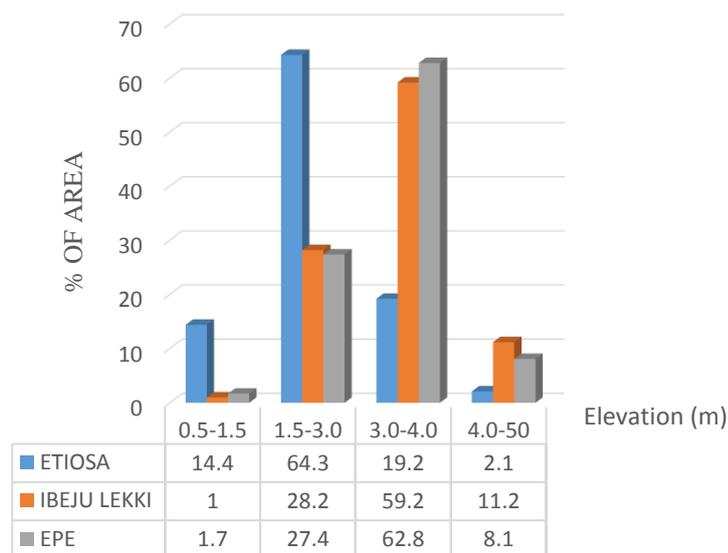
Figure 3.3: Histogram plot of elevations across LGA's.

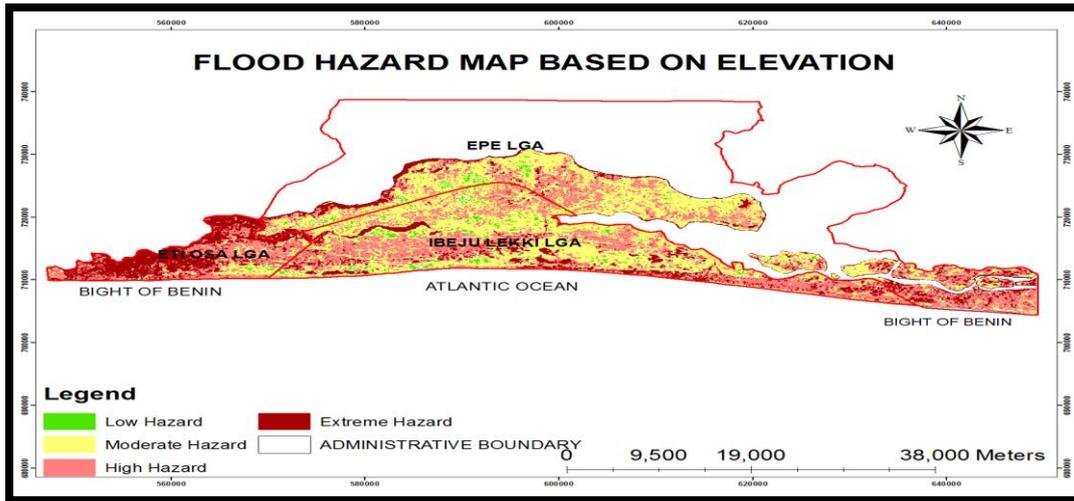
Figure 3.4: Flood hazard potential for both pluvial & marine flood based on planar water levels/elevation (0.51 – 2m = extreme hazard).

Evaluation of the potential risk to development on the island was performed by intersecting the elevation data with planar GIS or ‘bathtub fill’ water levels (Van de Sande, 2012; Poulter& Halpin, 2008; Bates et al., 2005) of 0.5 – above 4.1m from datum to derive a flood hazard potential for both pluvial and marine flooding. To evaluate coastal erosion risks, the minimum (5.42m), moderate (10.25m) and maximum (22.75m) erosion rates were radiated inwards from the coastline in 10-year intervals for 30 years of the most erosive area in Eti-Osa LGA to establish the extent potentially lost if the erosion rate is unperturbed. Image mensuration (Jensen, 2007) and valuation (Otegbulu, 2013) were done to estimate socio/economic impact on buildings and road assets in Eti-Osa LGA.

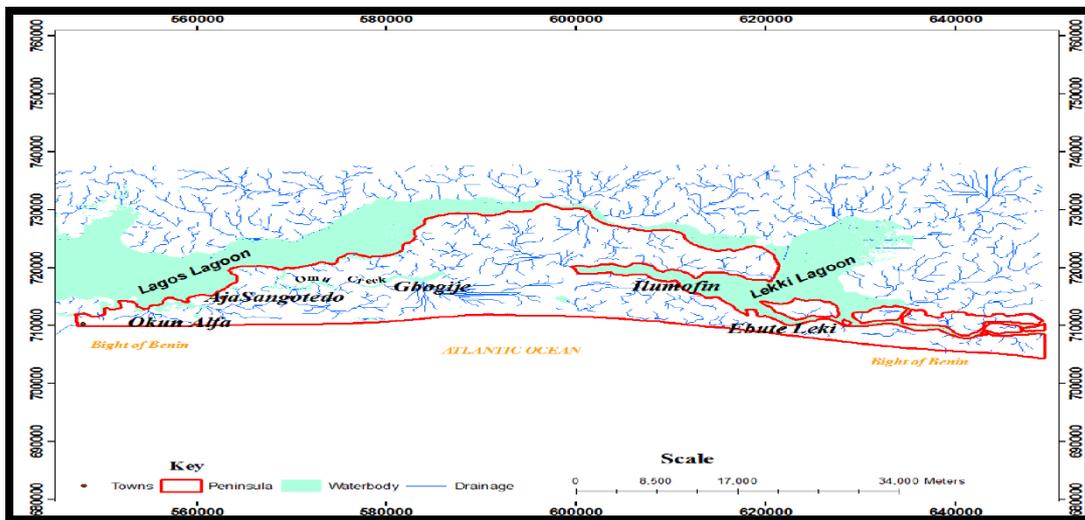
Figure.3.5: Surface drainage network and drainage basins or lack of in the Peninsula (Generated from SRTM DEM).

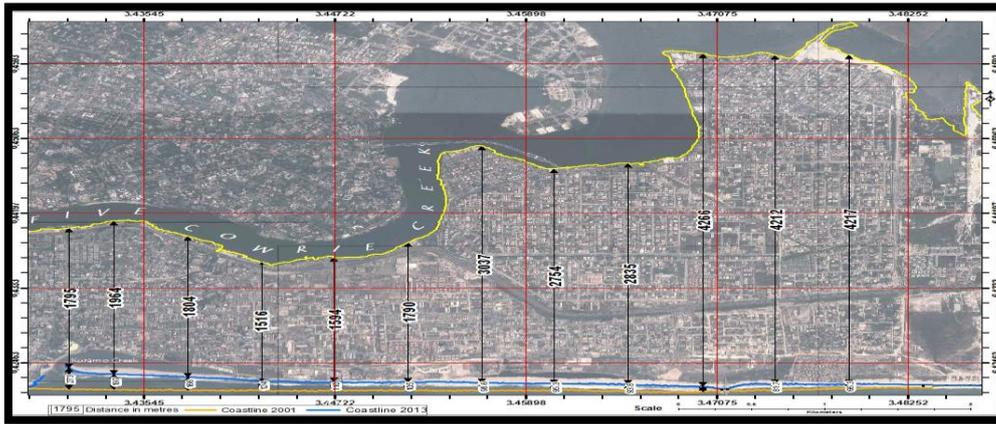
Fig. 3.6 Areas of maximum erosion in Etiosa LGA (Derived from Google imagery 2001 & 2013).

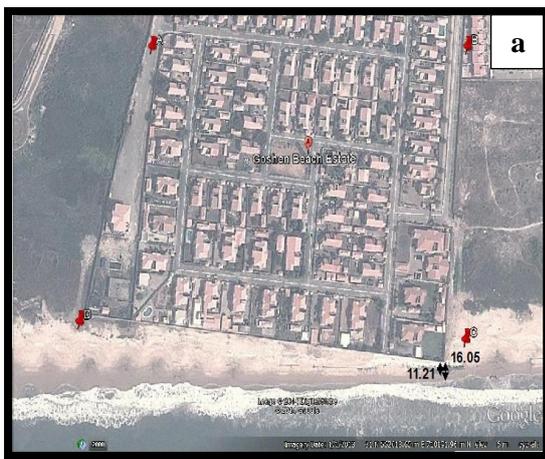
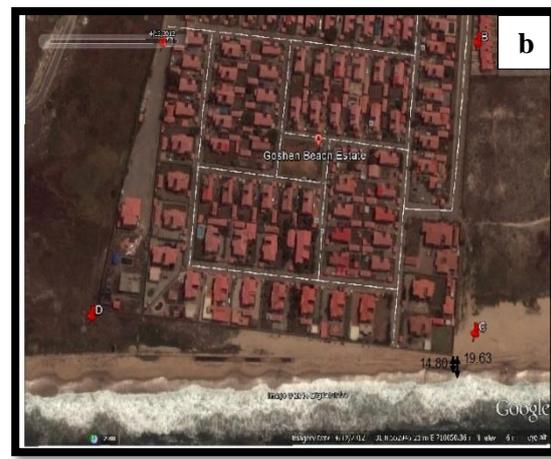
Plate 3.1a, b. Goshen Estate in 2012 and 2013 showing distances of the fence from the coastline. Note the beach configuration before the construction of groins; a. Goshen Estate in 2012 showing distance of fence from the coastline -19.63m & wet/dry line - 14.80m; b. in 2013 showing distance of fence from coastline – 16.05m & wet/dry line – 11.21m (after erosion/ocean surge of July 2012 (Imagery source: Google Earth, 2012 & 2013).

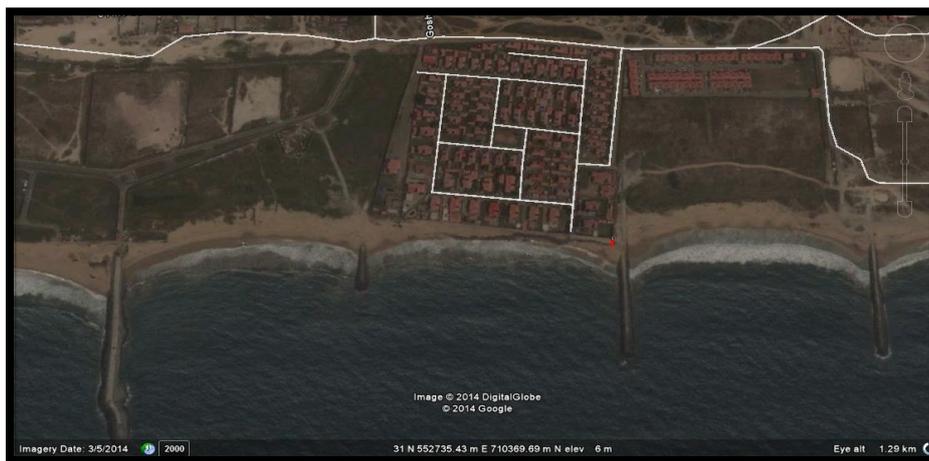
Plate 3.2. Google imagery of 5/3/2014 showing newly constructed groins around Goshen Estate and new u-shaped erosion/accretion between the groins. The new groins are apparent confirmation of extant serious erosion.

As is indicated above, some groins were shown to have been constructed on the coastline around Goshen Estate by March 2013. On Friday, June 3, 2016, The Guardian Newspaper (www.guardian.ng) ran an editorial based on the previous briefing by the Lagos State Commissioner for Waterfront Infrastructure Development titled 'Taming Ocean Surge in Lagos'. This was to the effect that the state authorities had earmarked N36billion for the construction of 18 groins at 40m intervals between Goshen Estate and Alpha Beach to the east at the cost of N2billion per groin. To be certain on the actual situation on the ground, a check on Google Earth imagery of 11/5/2016 revealed sixteen (16) groins spaced about 400m have been constructed from Goshen Estate past Maiyegun Beach towards Alpha Beach (Plate 5.1).

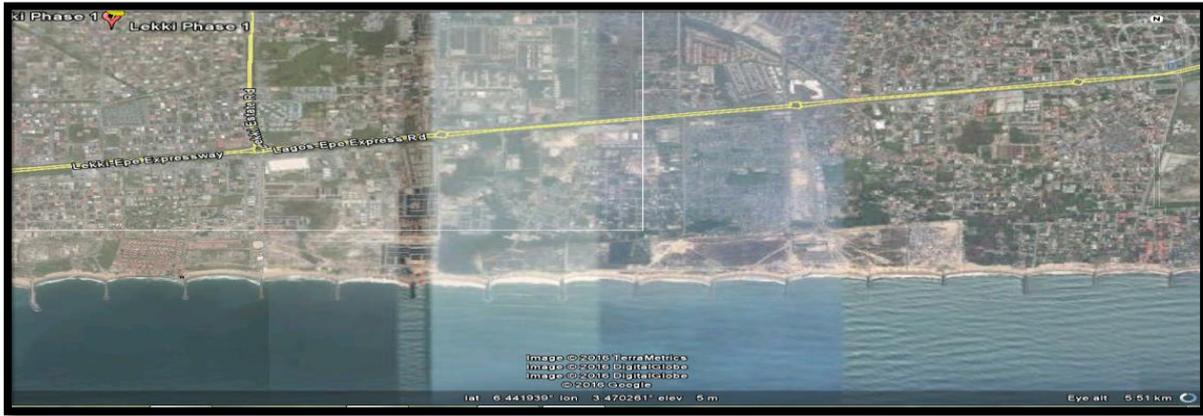
Plate 5.1 Imagery of 16 groins spaced about 400m from Goshen Estate towards Alpha beach as at May 11, 2016 (source: Google Earth, 2016).

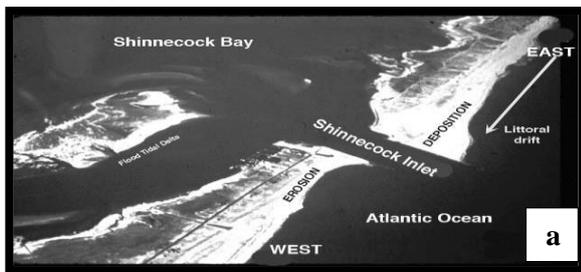
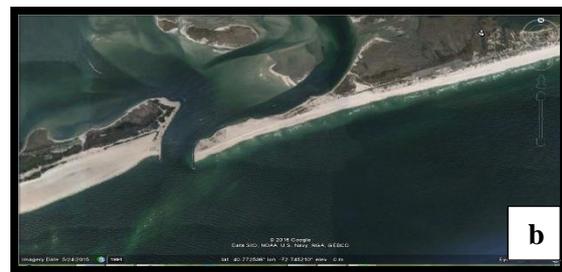
Plate 5.2: Erosion resulting from stabilisation of Shinnecock Inlet in Southampton, Long Island, New York. The up-drift side of the inlet (right) is accumulating sand against the jetty. The lack of sand supply on the down-drift side of the inlet causes erosion (source: Coch, N.K., 2015 & Google Earth, 2015; imagery date – 24-5-2015).

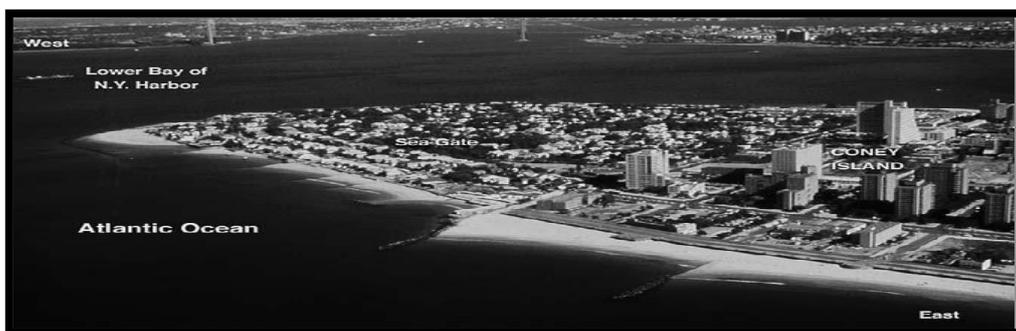
Plate 5.3 Aerial view of Coney Island at the western end of Long Island, NY. Relatively little sand manages to get here from its source in eastern Long Island. (Source: Coch, N.K., 2015).

some heavily developed while some are natural resource areas. After the 1938 hurricane, coastal engineering structures including groins, sea walls and jetties were viewed as means to increase beach width to minimise storm damage and to stabilise storm-cut inlets on Long Island (Coch, 2015; US Beach Erosion Board, 1946). Jetties were thus built to stabilise inlets such as Shinnecock Inlet in Southampton (Plate 5.2) and others. These jetties reduced the natural westward longshore sand movement along the south shore of Long Island resulting in sand accumulation on the up-drift or east side while the beach on the down-drift or west side of the inlet was severely eroded. The building of many groins to trap sand moving along the shore to widen local beaches and as storm protection measures, Coch (2015) concluded resulted in severe beach erosion of the western end of Long Island (Plates 5.3 & 5.4).

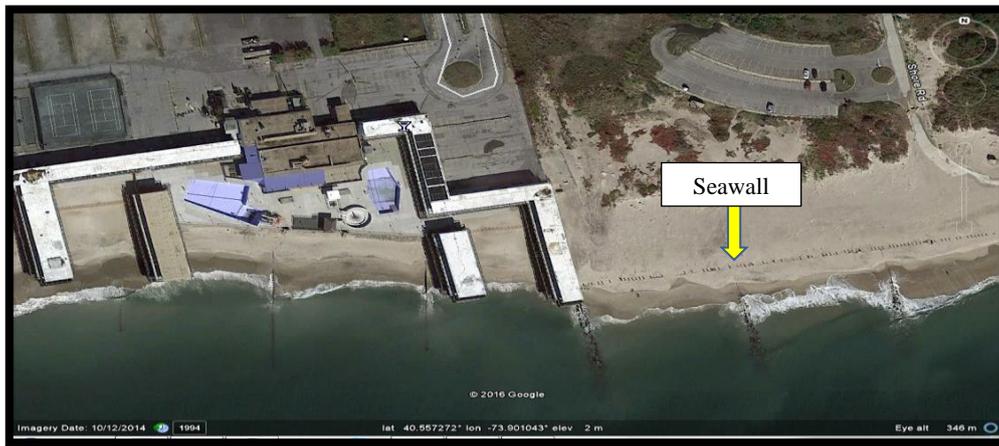
Plate 5.4 Even with groins, seawalls & palpable deposition, erosion is alive on Long Island barriers and the Cabana complex was at risk on 12-10-2014. Imagery captured on 12-10-2016. (source: Google Earth, 2016).
